Manhole Inspection Summary

Manhole # S45E2_002MH

Insp Date: **1/9/08 8:04 AM**

Location Address: **1408 Olmstead St**

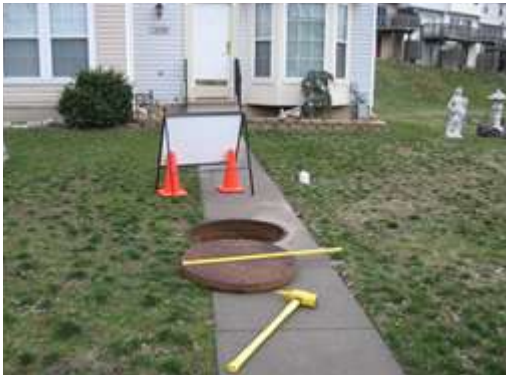
Location View

Olmstead St.

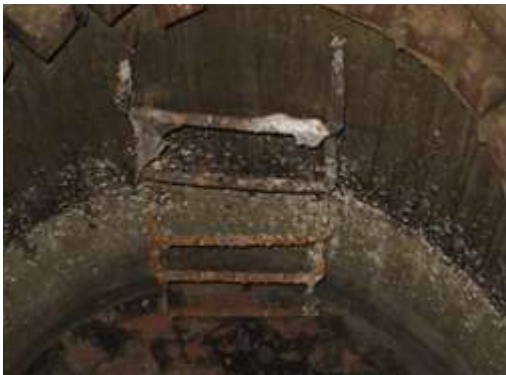
Steps Count: **5** Missing: **0** ☐ Corroded

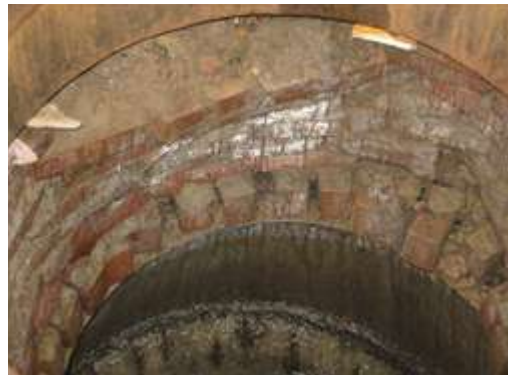
Defect 1

Condition: ☐ Sound ☐ Cracked ☐ Root Intrusion ☒ **Loose Brick** ☐ Deteriorated

Infiltration: ☐ None ☒ **Joint** ☐ Cracks ☒ **Mortar** ☐ Roots ☒ **Wall**

Chimney

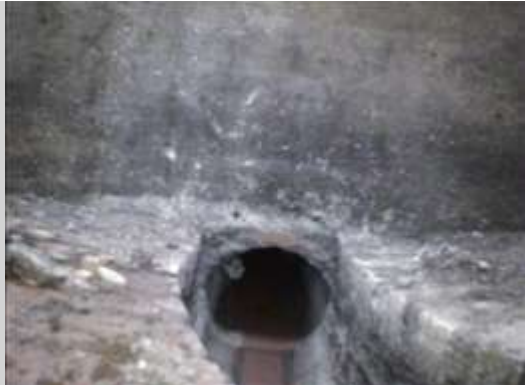
12 O'Clock Outflow

8 in. Circular Gravity Sewer
Pipe Out @ 12 O'Clock

Pipe Height: **8.4** (in.) Rod and Bar (Angled)
Pipe Material: **Clay** ☐ Pipe Lined
Invert Depth: **9.62** (ft.) Flow Characteristics: **Fast**
Deposits: ☒ None ☐ Mud ☐ Sludge ☐ Debris ☐ Grease
Silt Depth: (in.) Deposits Extent:
Infiltration: **None** Pipe Seal Cond: **Sound**

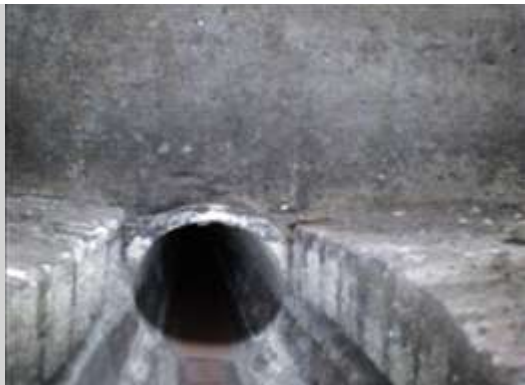
5 O'Clock Inflow

8 in. Circular Gravity Sewer
Pipe In @ 5 O'Clock

Pipe Height: **7.2** (in.) Rod and Bar (Angled)
Pipe Material: **Clay** ☐ Pipe Lined
Invert Depth: **9.46** (ft.) Flow Characteristics: **Fast**
Deposits: ☒ None ☐ Mud ☐ Sludge ☐ Debris ☐ Grease
Silt Depth: (in.) Deposits Extent:
Infiltration: **None** Pipe Seal Cond: **Sound**
